**CHRIST CHURCH  
LONDON ROAD/SILCHESTER ROAD  
ST. LEONARDS ON SEA  
EAST SUSSEX**

**DIOCESE OF CHICHESTER  
CARE OF CHURCHES AND ECCLESIASTICAL JURISDICTION MEASURE 1991**

## **QUINQUENNIAL INSPECTION REPORT**

**November 2018**

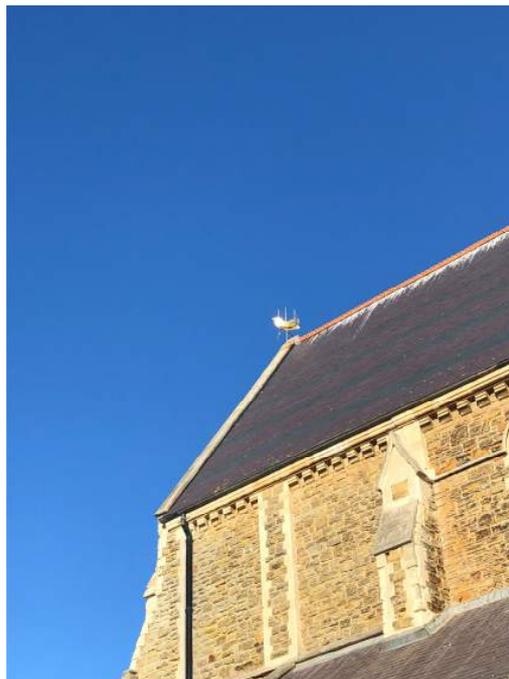
At the apex of the western wall there is an impressive gilt galleon weathervane; the sail of the vessel having fallen during a recent storm and two of the cardinal points are also missing. I advise that the repair of this important weathervane could be the subject of an insurance claim.

There would appear to be a crack and open joint in the gable stone beneath the weathervane on the south side and it would be wise to have this repaired when access is available.

*The scaffolding to reach the weathervane would perhaps allow for some external stonework repairs to be carried out to the west wall; this would be outside the insurance claim.*

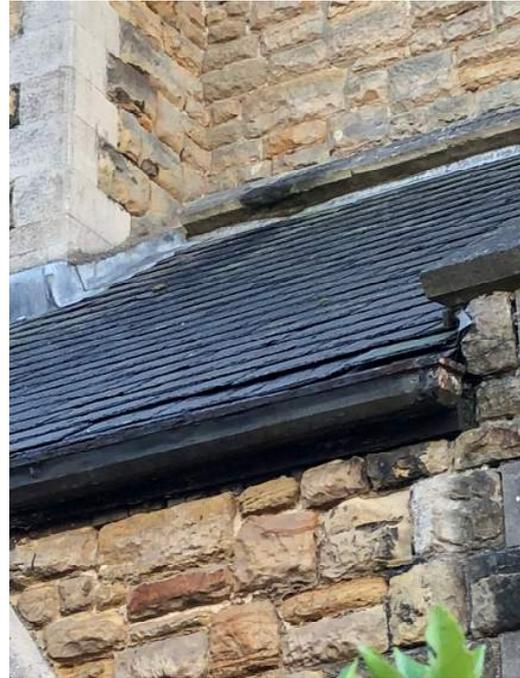
There is some disturbance to eaves slate in the northwest corner beyond the northwest Porch where there appears to be a depression in the timber fixings. Keep under review.

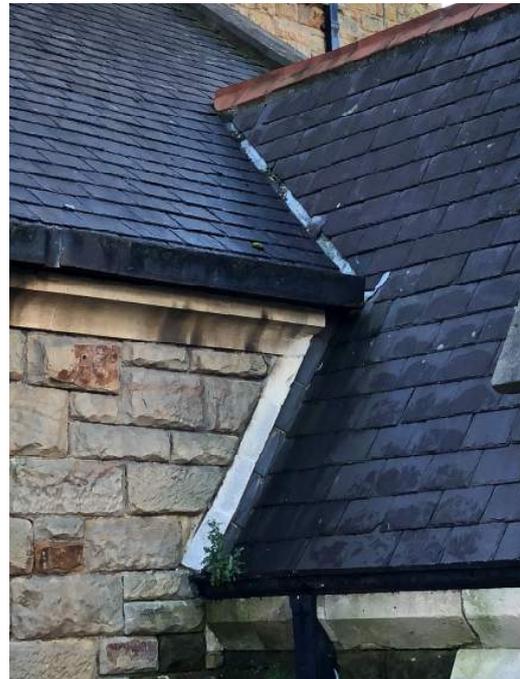
The junction between the roof and the raised walls of the clerestory is with lead apron flashing which appears to be in a generally serviceable condition; there are some gaps in joints, although this is minimal. Keep under review.

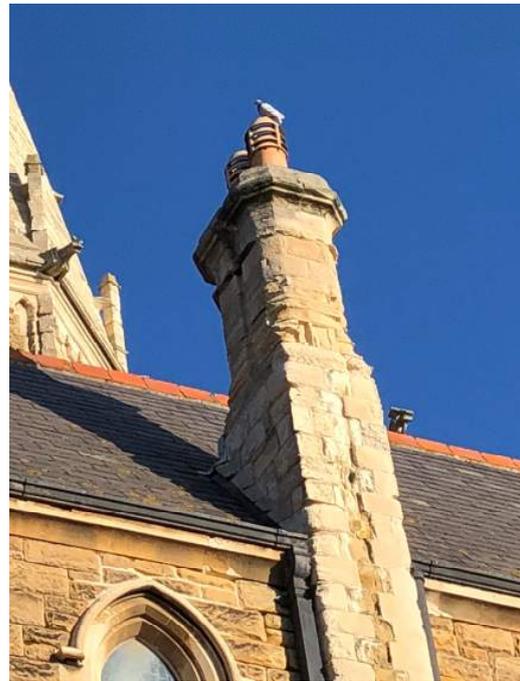
A chimneystack penetrates this roof from the south side where there is erosion to the stone. Keep under review. The pots and flaunching to the chimneystack could not be seen. It would appear that this stack is redundant, having originally served fireplaces in the Vestries below.

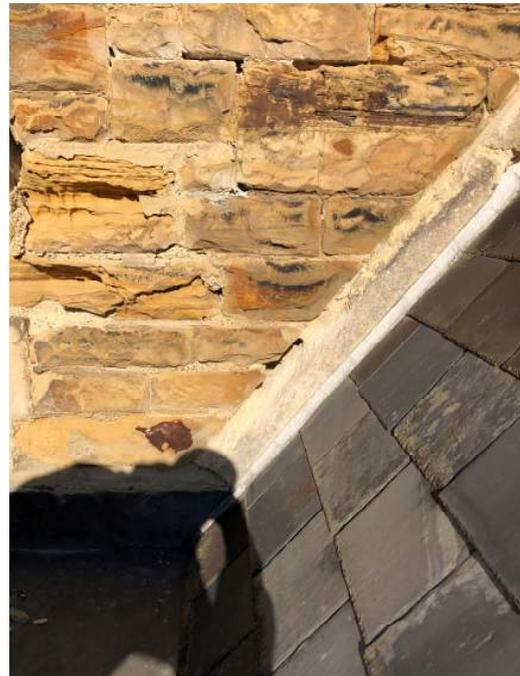
Some repairs are required where slates have slipped, and the valleys and parapet gutters require clearance of debris. In general terms it appears that the lead valley gutters are performing adequately, although they have steps which are not compliant with current recommendations issued by the Lead Sheet Association and as such there may be the occasion of leakage due to capillary attraction, particularly at times when the lead valleys may be blocked in debris. Keep under review. Flashing to the inside of the gutter requires re-setting.

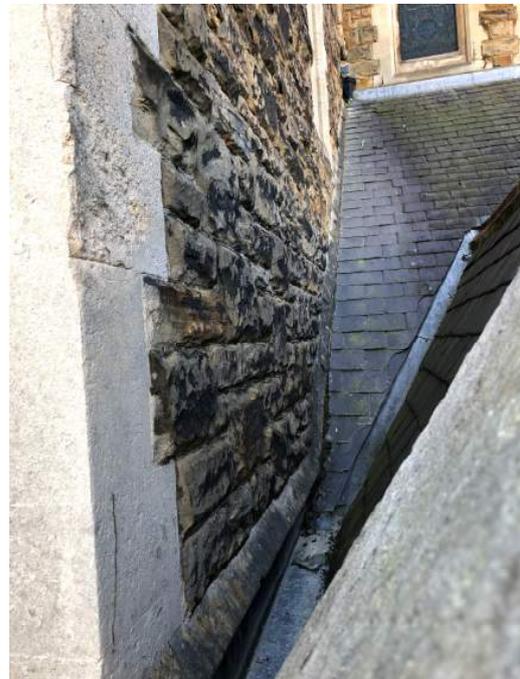
- 5.7 The dual pitched roof to the Lady Chapel on the north side is also finished in Welsh slate with lead weatherings. A short section of lead valley at the junction with the Tower is clear, although as with other areas, is not compliant with the current Lead Sheet Association recommendations.

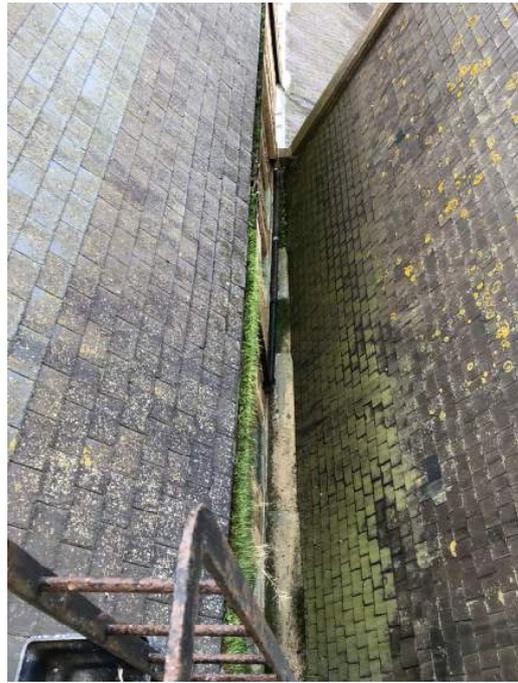
- 5.8 The valley gutter on the south side of this roof and at the junction with the Nave is finished in lead; much choked in debris and requiring clearance.

*There is damp staining at eaves level on this south side of the Chapel which may be caused by some defect. I advise a closer inspection when access is available.*

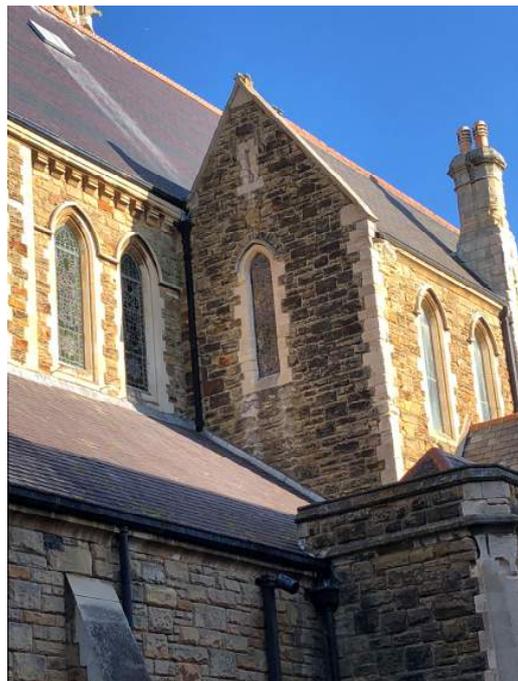
- 5.9 There are a number of lost ornamental crosses or other features at gable apices.

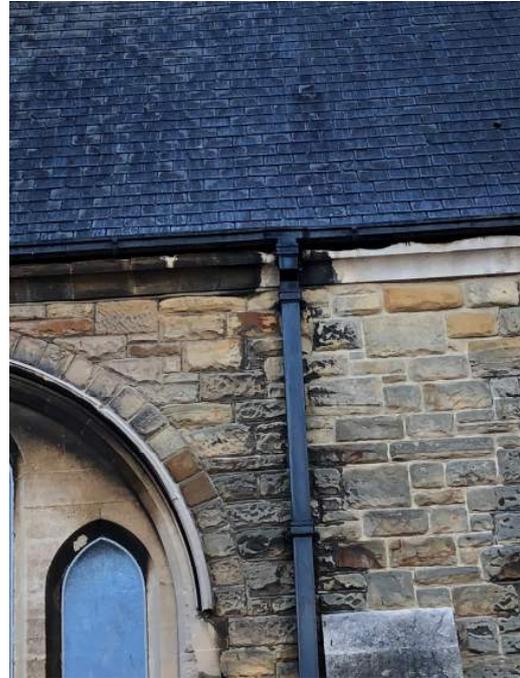
All are in need of overhaul, re-sealing gutter joints etc., and redecoration. It also seems probable that there will be some repairs required when gutters have been cleared, which might identify cracks and defects.

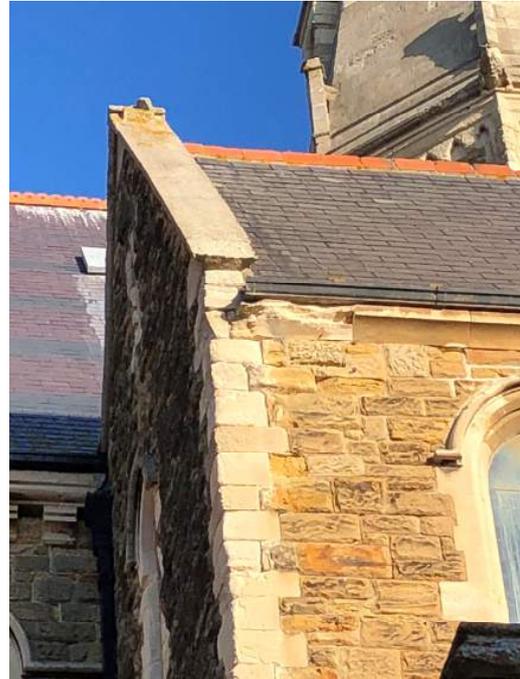
- 6.5 Stone erosion at either end of the eaves gutter to the south side of the south Chancel Chapel and staircase area may be affecting the stability of the gutter fixing.

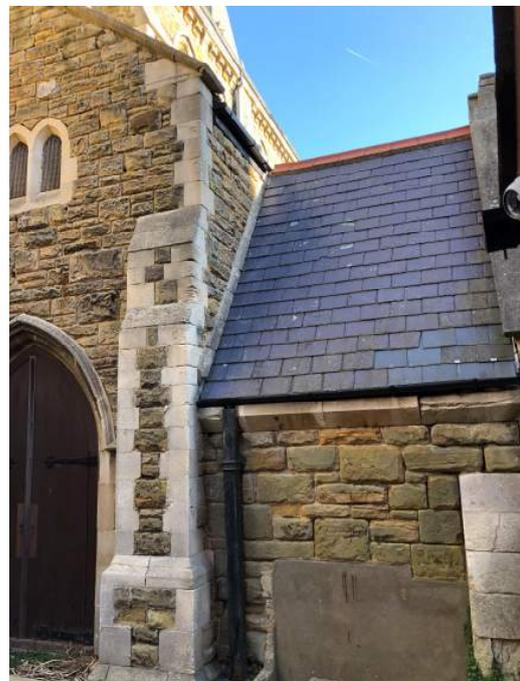
- 6.6 Two sections of UPVC gutter are fitted to the short eaves of roofs to the west side of the southwest Porch/entry to the Crypt and at the junction with the South Aisle roof. These gutters should be replaced in cast iron.

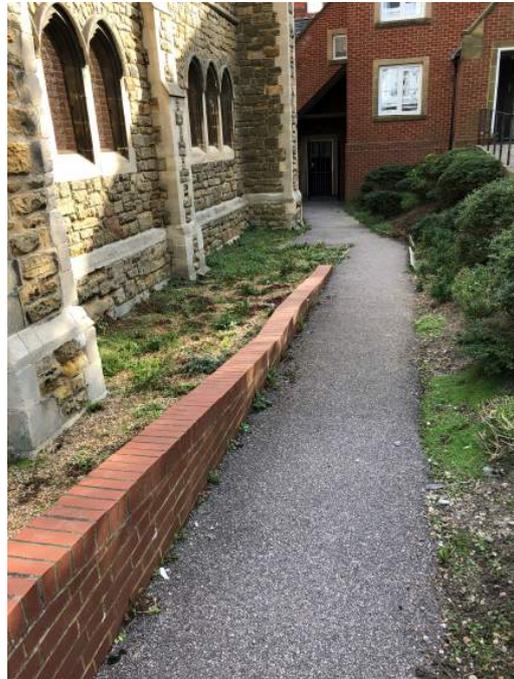
- 6.7 The intensity of rainwater disposal during storm conditions will be excessive and may lead to saturation of grounds surrounding the Church. In general terms on the north and south sides this would drain over hard pavings, but on the west side into an area that is finished in gravel.

The gravel is over UPVC netting as weed control, but this may in effect cause ponding or excessive dampness by drainage against the external walls and might be a contributory cause to the dampness showing at the west end of the Crypt. I advise a further investigation.

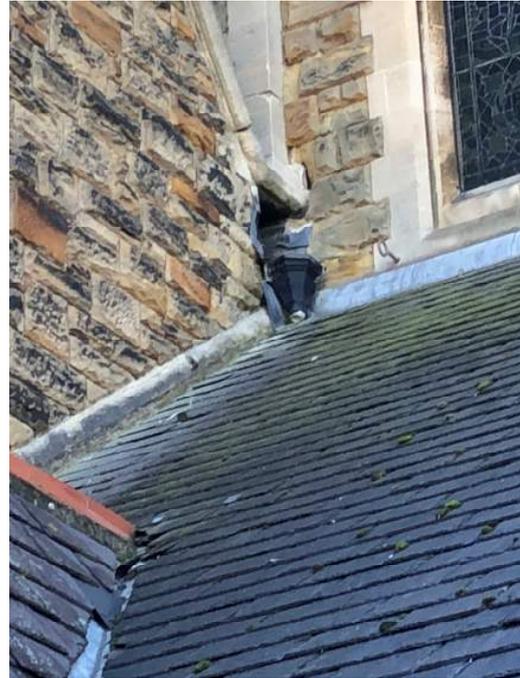
- 6.10 There is a hopper at the outlet to the lead valley between the Lady Chapel and Chancel; this will receive a significant amount of rainwater disposal during storm conditions and is likely therefore to overflow and lead to significant run of rainwater over the North Aisle roof, possibly affecting the west wall of the Chapel. I advise the fitting of some lead deflectors to encourage the rainwater away from this vulnerable location.

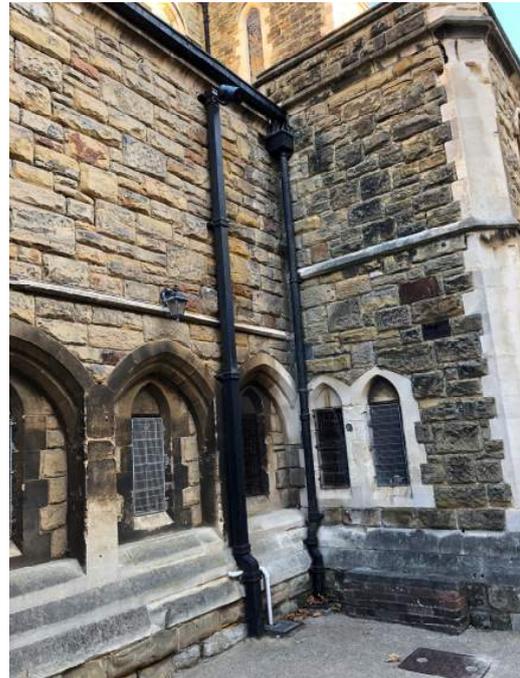
- 6.11 The rainwater pipes which serve the lower gutters to the North and South Aisle roofs are of a similar size to the rainwater pipes which serve the higher level gutters to the north and south sides of the Nave, although they take significantly more rainwater.

There seems to be a redundant square section of rainwater pipe to the south side which, if it proves to serve no purpose, it would be wise to remove.

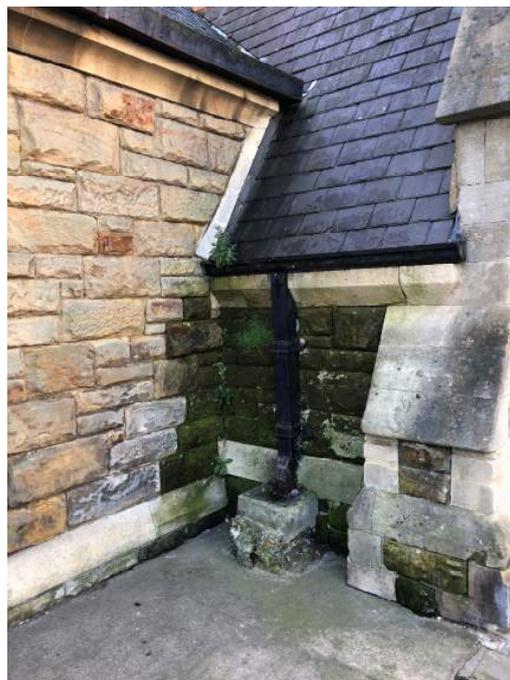
- 6.12 To the east side of the northwest Porch the gutter receives a significant amount of rainwater from the North Aisle roof and overspill is evident by way of green growth on the stonework.

- 6.13 Clean and keep clear all rainwater gullies.

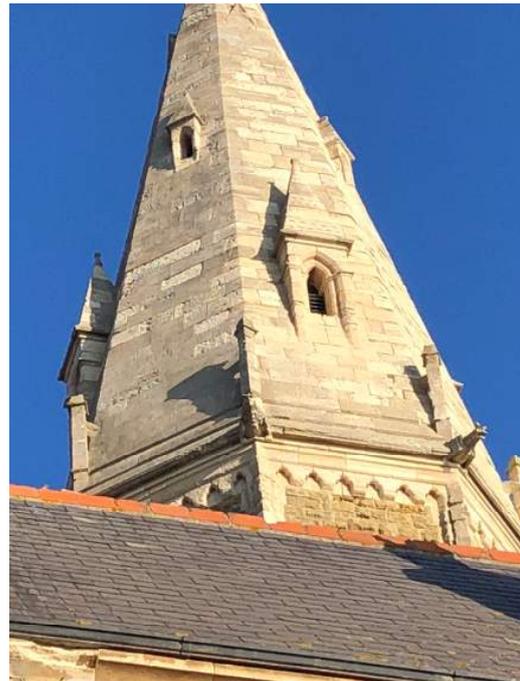
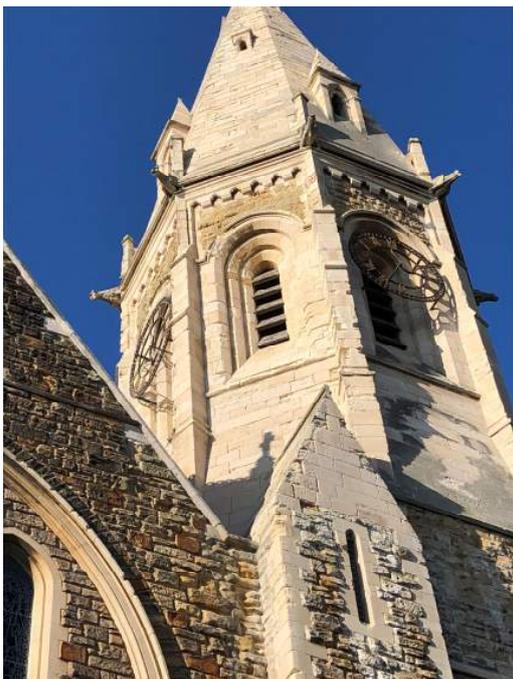
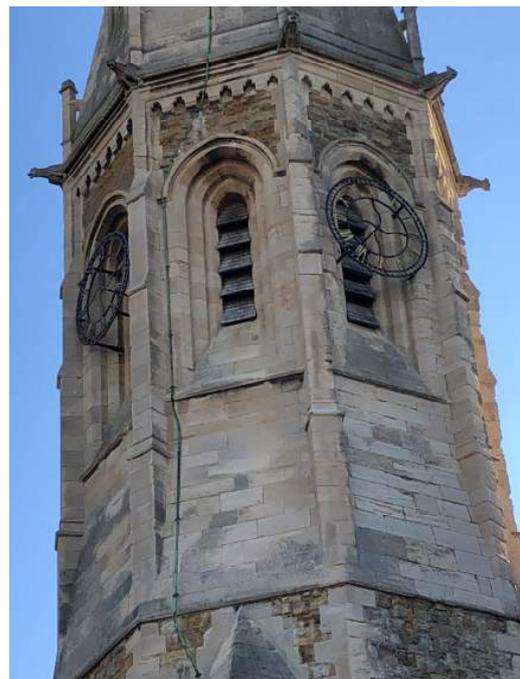
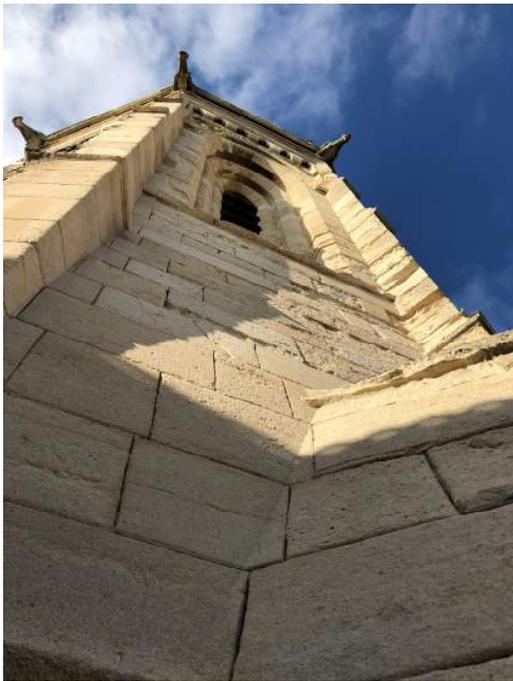
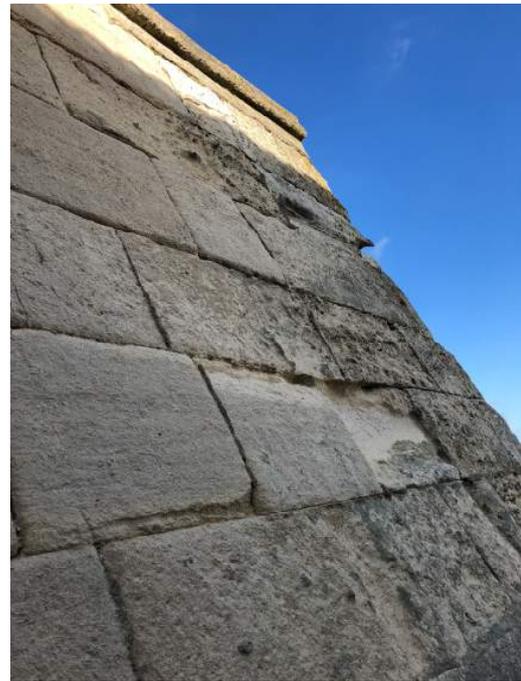
- 7.2 The extent of erosion is more significant to the south and west elevations due to exposure, and particularly to the high levels of the Tower and Spire.

The extent of review of stonework to the Spire is limited due to means of access, but it is evident that many details have eroded and sections of stone, in all probability, have already fallen to the grounds below.

It is evident that there have been past repairs to the Spire stonework. It is also evident that there are many open joints to stone and eroding stone faces. Such erosion is showing as “dust run” down the faces of some of the Tower.

Deep open joints to stonework will require gravity fill by way of grouting, together with pointing in an appropriate lime based mix. Some stones will require replacement.

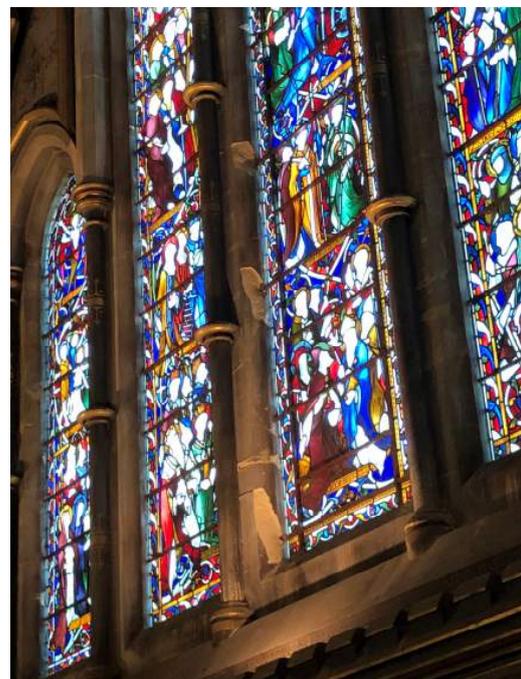
- 7.3 Some stonework is being affected by rusting steel, being part of window framework and protection, both externally and internally where there is spalling of saddlebars; for example the main east window.

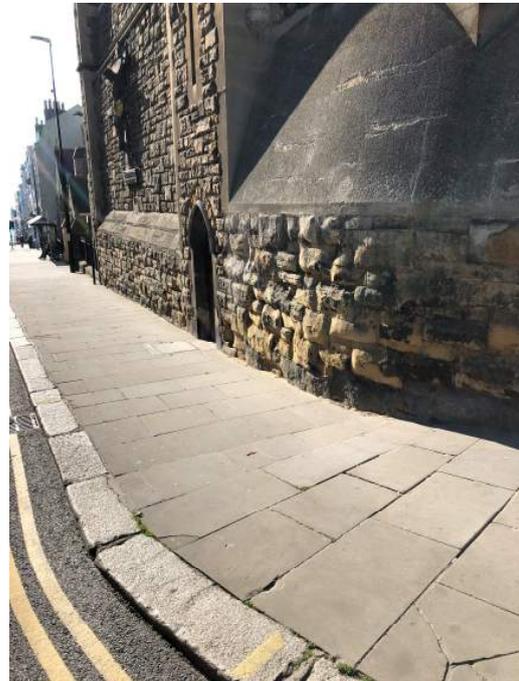
- 7.5 There is erosion of stonework to where this is subject to water splash and surface dirt; to the elevations to London Road and Silchester Road.

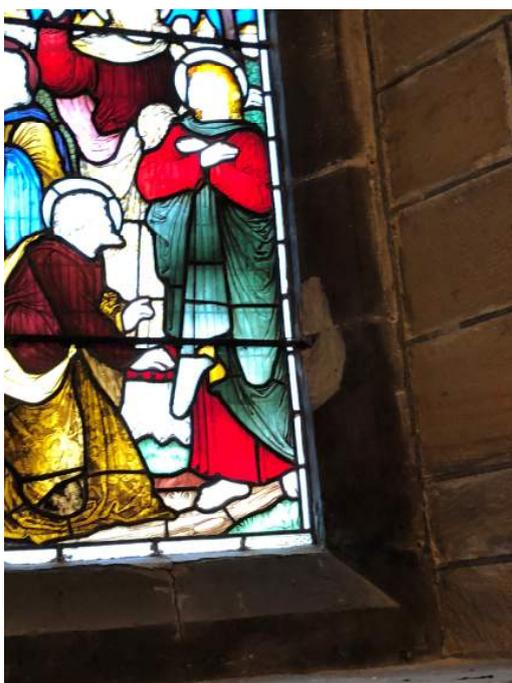
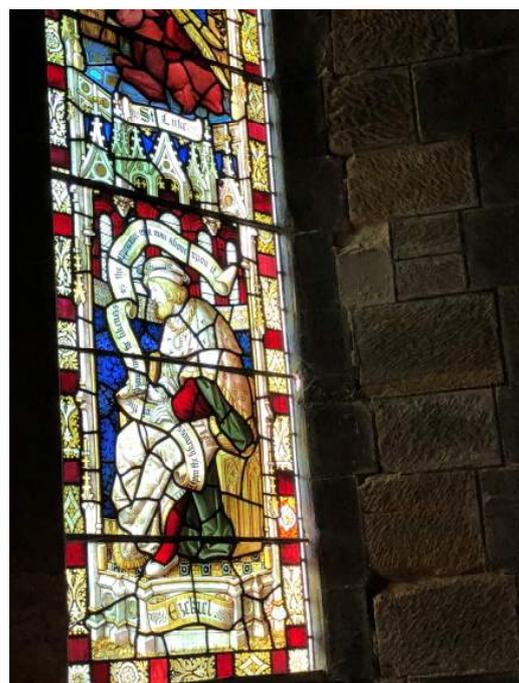
- 7.6 The erosion of stonework around windows with deep fissures will be affecting the weathering between the leading of the window and stonework and will result in gaps which will allow water penetration. This is clearly the case to the west window above the organ Gallery.

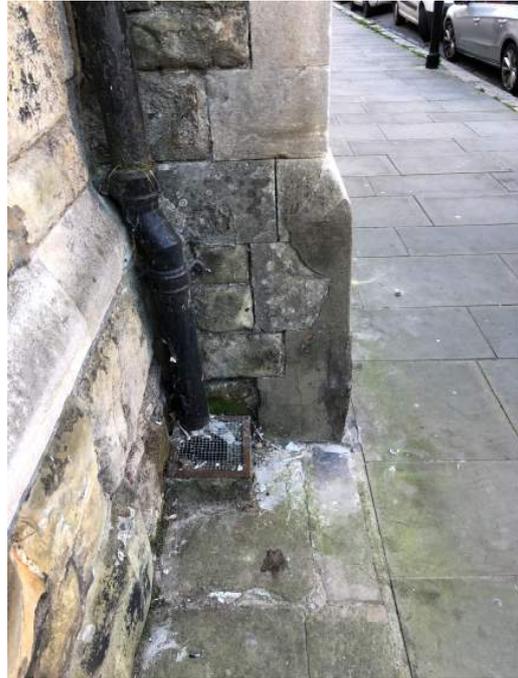
- 7.7 There is deterioration to the plinths close to the entry/exit doors to the northeast and northwest Porches.

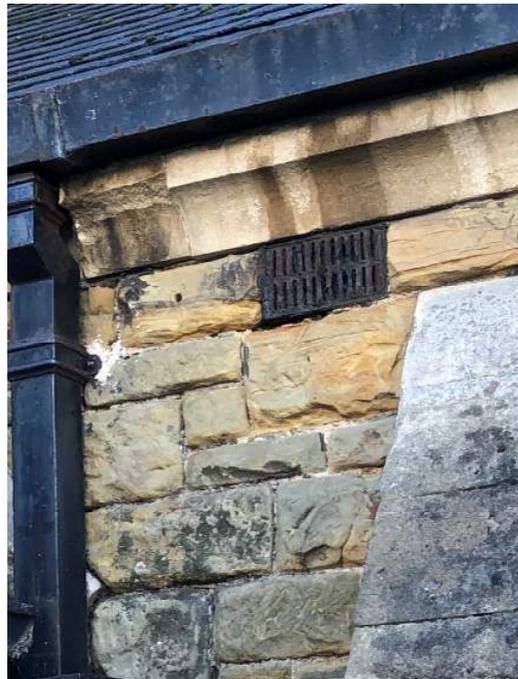
- 7.8 Corroding metal airbricks in external walls require replacement. The rusting will cause spalling to stonework and the corrosion is limiting air movement.

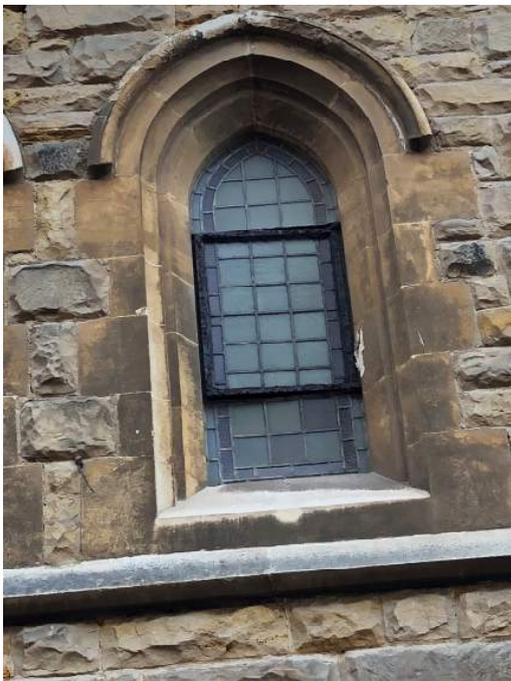
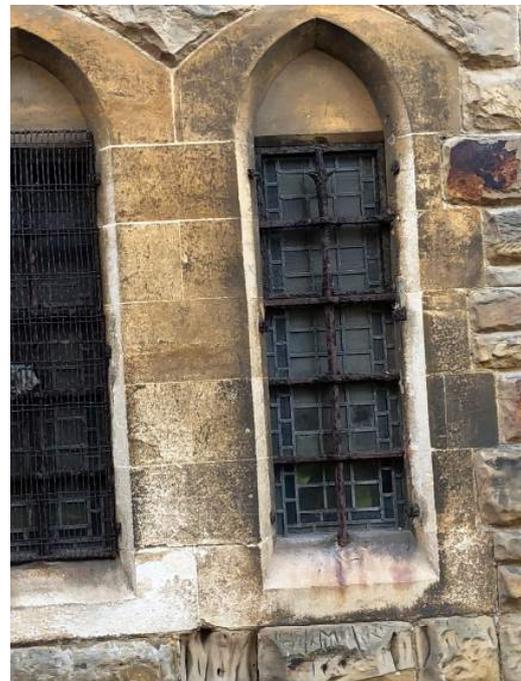
Where windows have ferrous metal casements and fittings such as saddlebars and ferramenta, these are generally in a corroded state, not unsurprising in the aggressive environment. Early repair and restoration is advised in order to avoid extensive damage to stonework, but also to window glass which will be under pressure and subject to cracking and breakage.

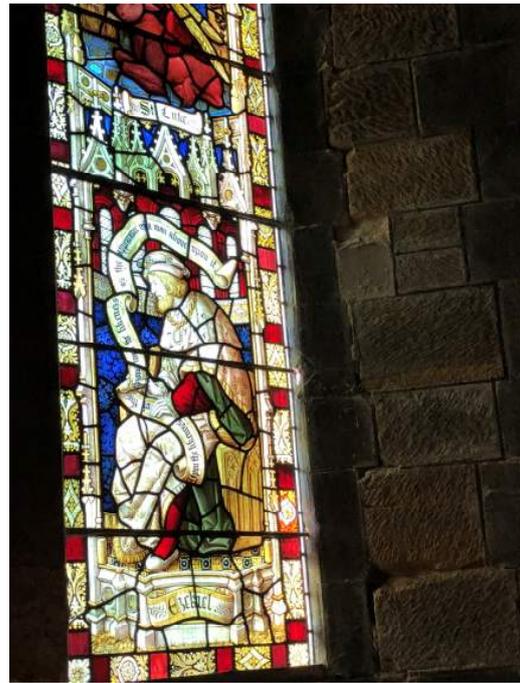
- 8.3 As previously mentioned, erosion to stone surrounds by deep fissures will be causing some gaps at the junction of leaded windows to stonework allowing for rain and wind entry. This is evident through the fine west windows where daylight can be seen; such air passage will exacerbate erosion.

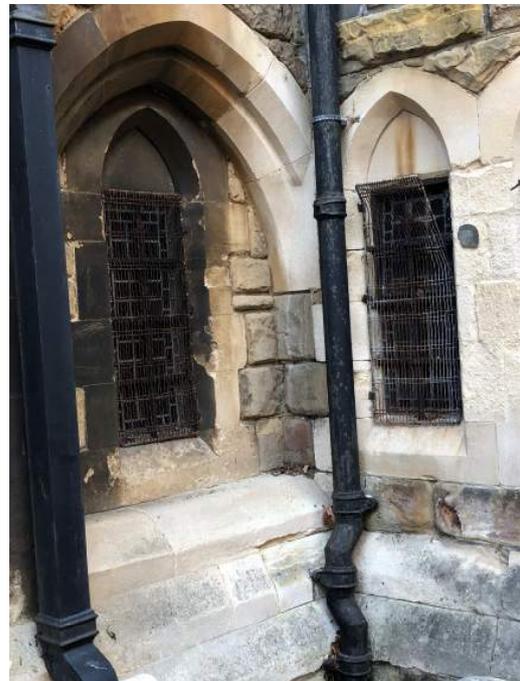
- 8.4 Windows are protected in various arrangements. To the higher levels of the west, north and south sides in black powder coated stainless steel guards which generally appear to be in fair order, although it is unfortunate that the fixings are not through the mortar joints in the stone.

Where window grilles are provided in galvanised metal or rusting metal, these are unsightly and display a neglected appearance. If there is continuing cause for concern in respect of security these grilles would benefit from being replaced; if not the grilles could be dispensed with.

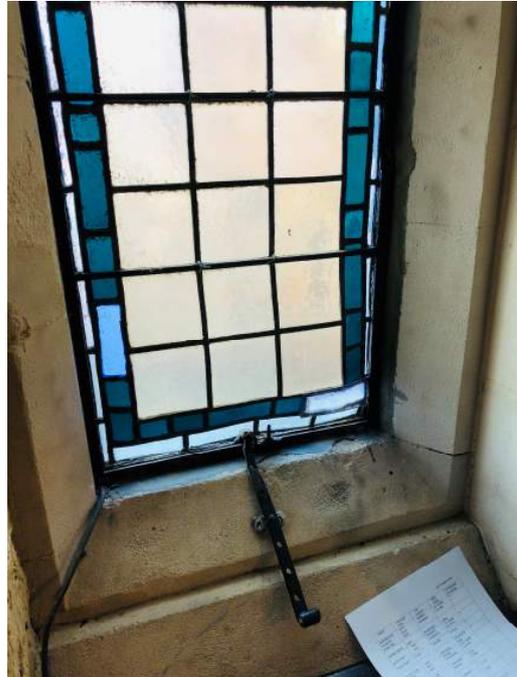
8.6 It is evident that a number of windows have internal saddlebars, some of which appear to be light in size. These are important to maintain and stabilise the leaded windows and avoid windows being subject to thermal stresses which lead to slumping. It is evident that some window glass is out of alignment, probably due to the failure of the saddlebars and or rusting.

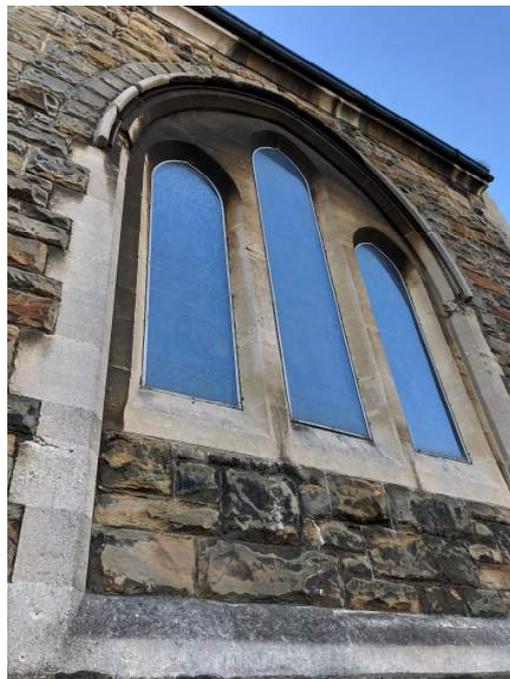
- 8.9 The three lancets in two window forms to the Lady Chapel on the north elevation and to the east facing windows are protected with outer glass sheet in a frame. One section of glass appears to be cracked.

This form of protection is not considered appropriate as it can lead to a microclimate being formed between the two sections of glass, the leaded window and the outer glass, which can cause movement in the leading and stained glass. There is also no means of cleaning any debris that may arise between the two sections of glass.

I advise that where windows have such protection, which includes the two high level windows to the Chapel on the south side of the Chancel/staircase, this should be replaced in black powder coated stainless steel.

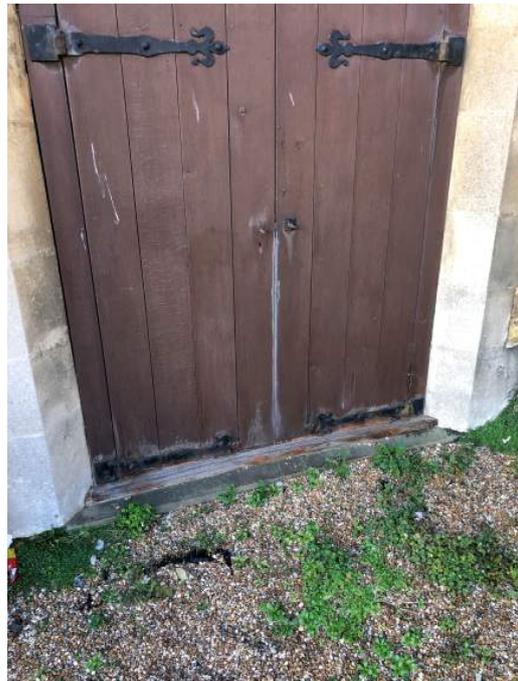
- 9.2 It is also evident that some doorways are closed and out of use and I advise that the weathering at junctions is reviewed to overcome any possible damp and water penetration, for example the two doorways in the west walls of the northwest Porch and Calvary Chapel.

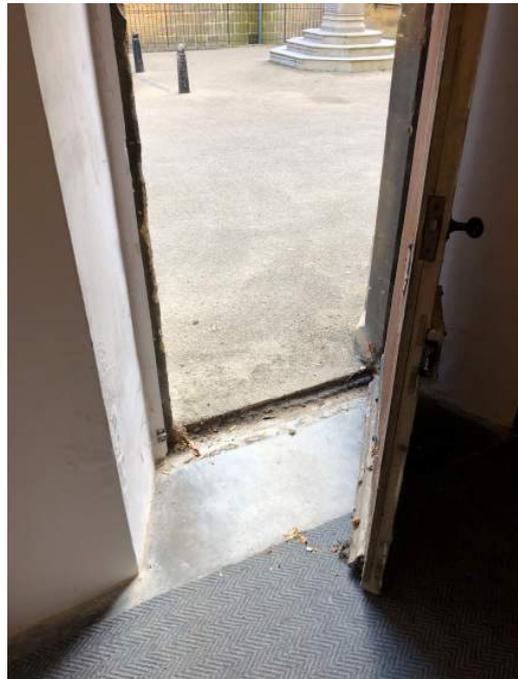
- 9.3 It is also evident that many of the doorways have level thresholds and as such, during storm conditions, water penetration will occur and this could lead to a further situation of damp penetration in structures.

For example to the escape door from the lobby outside the Servers Vestry, the paving is higher than the door and without any threshold.

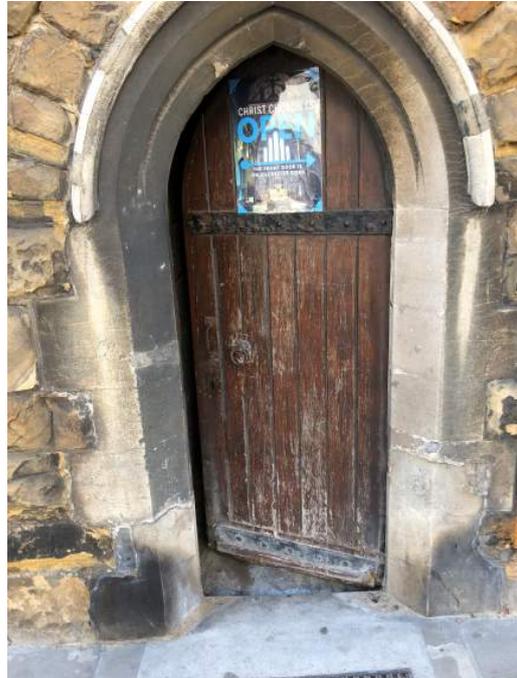
It seems probable that during storm conditions, water may run under the doorway into the space below the spiral stair. This will be adding to the probability of dampness within the structure.
