**CHRIST CHURCH  
LONDON ROAD/SILCHESTER ROAD  
ST. LEONARDS ON SEA  
EAST SUSSEX**

**DIOCESE OF CHICHESTER  
CARE OF CHURCHES AND ECCLESIASTICAL JURISDICTION MEASURE 1991**

## **QUINQUENNIAL INSPECTION REPORT**

**November 2018**

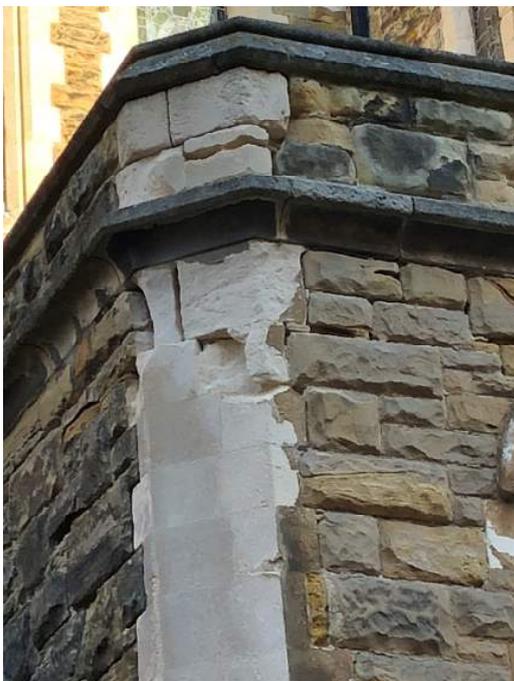
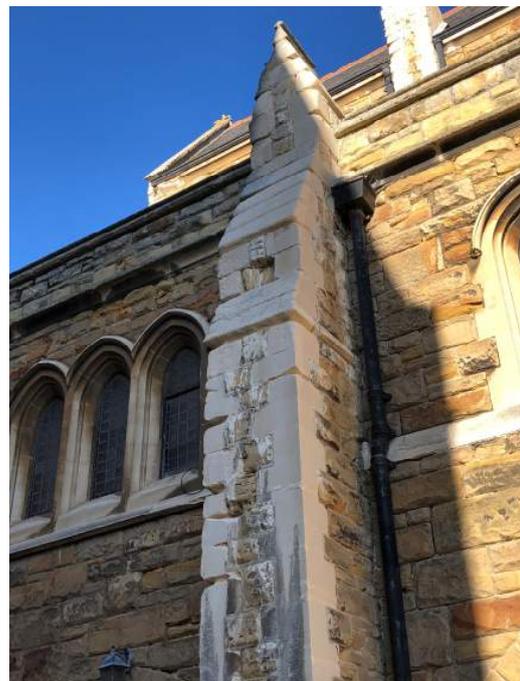
- 3.9 The external walls of the building are finished in rock faced ashlar sandstone with limestone dressing. It is thought that much of the stone would have been locally sourced, although it has been recorded that the limestone is a Bath stone, not known for good weathering in buildings close to the coast.
- 3.10 There is significant deterioration, more particularly to the limestone dressings and stringcourses, but also erosion of pointing between main ashlar stonework which requires early restoration; the gaps are such to allow for significant water uptake to the main structure.

The deterioration of stone is a natural process of crystallisation of salts which expand below the surface and can cause spalling or loosening of the surface of the stone resulting in a friable surface which can take up moisture to perpetuate the decay.

- 3.12 There will be significant cost in stonework repairs and associated works, in view of the impressive scale of the buildings. I advise a programme of stonework repair to be carried out over a period of time and as and when funds permit.

- 3.13 It will be important with any repairs that are carried out, to use a lime based mix for external pointing and a suitable stone of durability in the salt laden atmosphere so close to the coast. To also use materials that will allow for the adequate breathing and release of moisture and protect the important stonework. In addition internal paintwork to be microporous in order for the release of moisture.

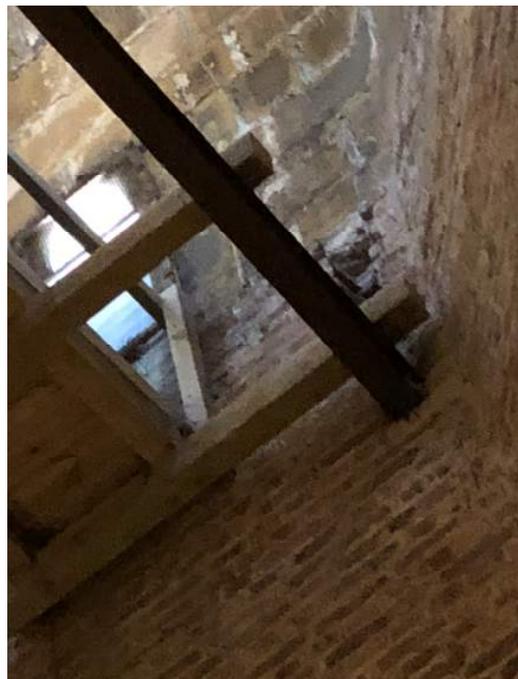
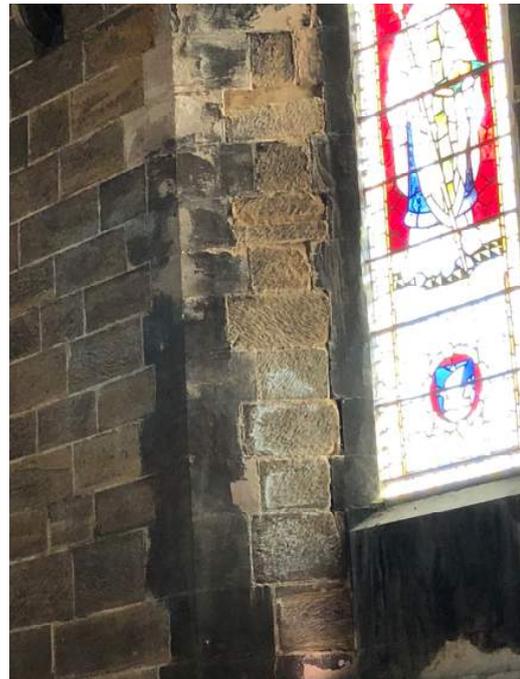
- 3.15 Internal deterioration of stonework and efflorescence arising from mortar joints etc., is in all probability due in part to condensation and high levels of internal humidity.

- 3.16 The buildings have a comprehensive heating installation, although the efficiency is not known. The control of condensation is the balance between heat, insulation and ventilation. There will be no insulation in the early forms of construction, and there will therefore be significant thermal loss through the structure, particularly the roof. The balance of internal conditions is therefore dictated by the heating levels, preferably 12-16°C, to ensure that the main structure is kept to a warm temperature in order to avoid the take-up of condensation, and natural ventilation. There is very limited ventilation due to the poor condition of opening windows and this should be reviewed.

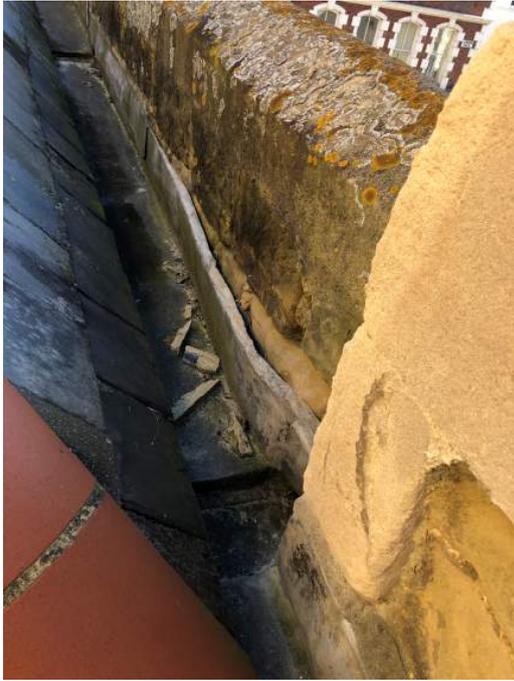
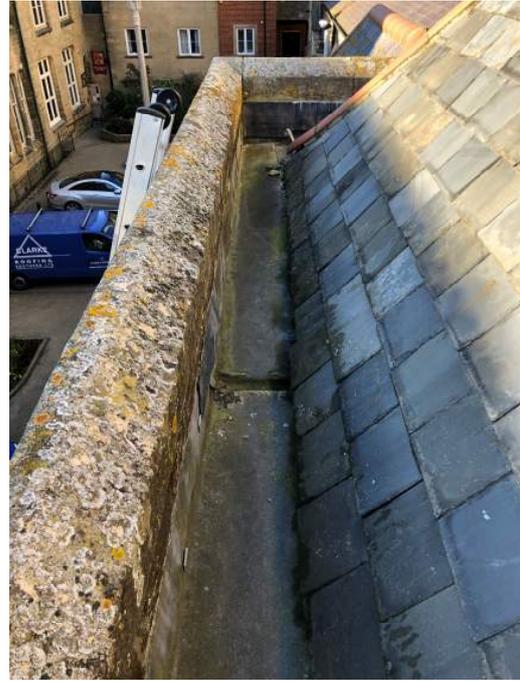
- 5.6 The lead valley gutter between the dual pitched roof of the south Chancel Chapel and Chancel could not be seen due to limited access. There is an outlet to the west end where there is a rainwater head and rainwater pipe. I advise inspection of this lead valley when access is available.

*The present vertical timber ladder leading from the Chapel to the roof outlet is not safe to use.*

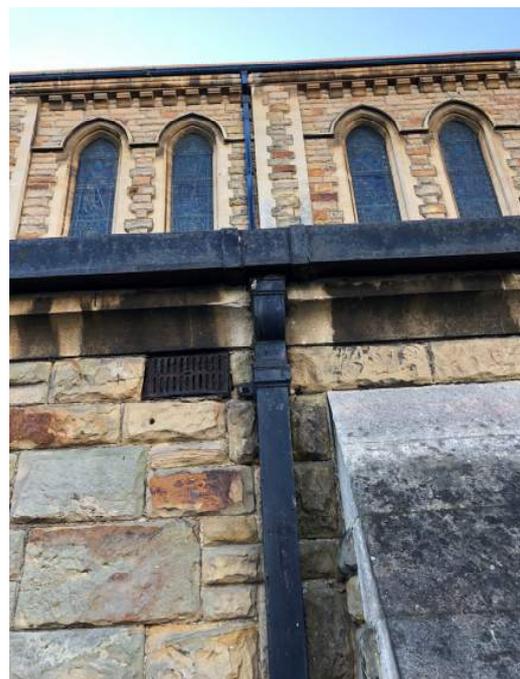
- 6.3 The gutters which are fitted to the eaves of the Nave and Chancel, North and South Aisles sit on stone stringcourses and as such any leakage will be causing deterioration to the stone.

- 6.4 Rainwater pipes are generally in square section with ornamental cast iron rainwater heads. There are a number of bends in the rainwater pipes which might be easily clogged in debris, particularly where moss etc. falls from the north facing roofs.

There is an amount of debris, grass and weeds etc. in the eaves gutters on the north side of the Chancel which requires early clearance. This will be causing overspill and may be a contributory cause to the damp staining seen within the high level of the Chapel.

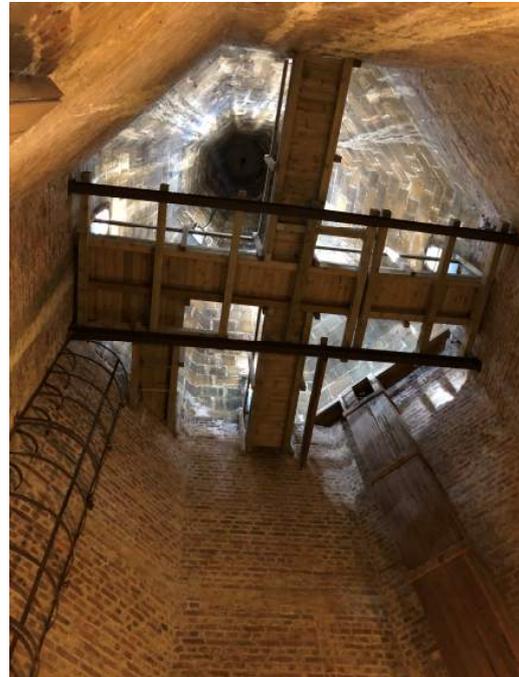
10.10 The upper walls of the Tower within the Belfry are in brick up to the lower section of the lucarnes and from there to the apex in exposed stone. There are a number of runs on the stone suggesting water and damp penetration; it is not known whether this may be historic. There is much ventilation between the lucarnes. It is not known whether bats inhabit any of the upper spaces.

10.11 A vertical steel ladder gives access to higher levels of the Spire, but this was not used at the time of this inspection due to safety issues.

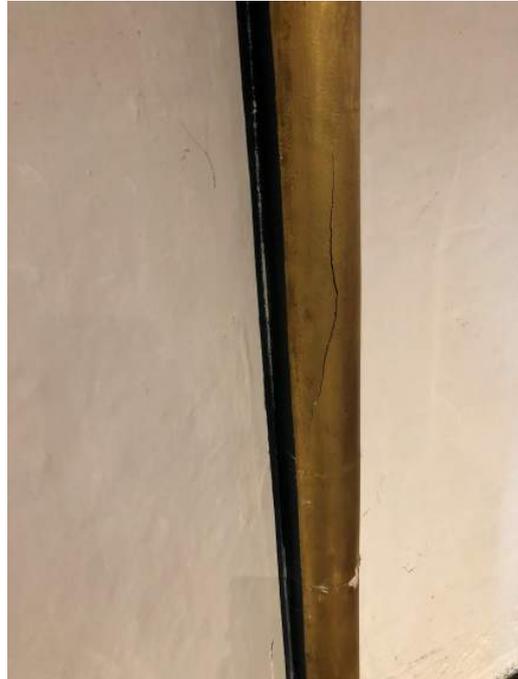
11.2 Painted boarding to the roof timbers of the Lady Chapel with plastered and decoratively painted vaulted roof with raised ribs to the Sanctuary of the Chapel. Gilt shafts; the one on the north side cracked.

There is damp staining below valley gutter on south side at the junction with the Chancel.

Ceiling paintwork to the vault is deteriorated in part and I advise inspection by a specialist Conservator.

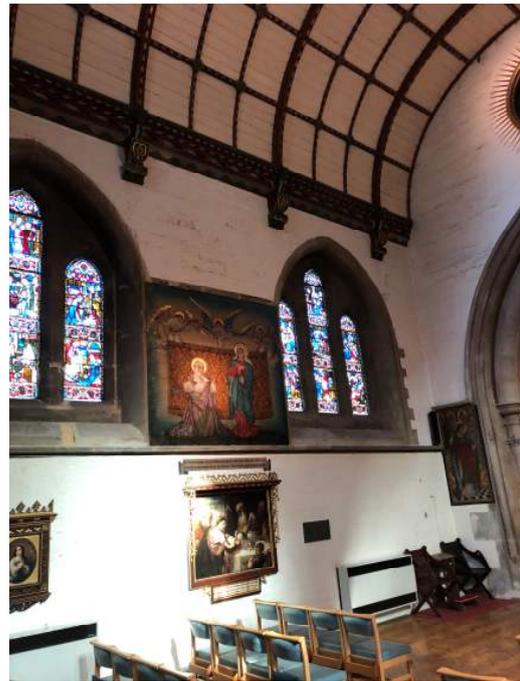
- 12.3 It is unfortunate that the outer walls of the Chapel have also been painted. This gives a rather stark appearance when looking into the Chapel from the Nave; an improvement might see a softer colour.

There is some disturbance to lower levels of painted decoration caused by rising and penetrating dampness.

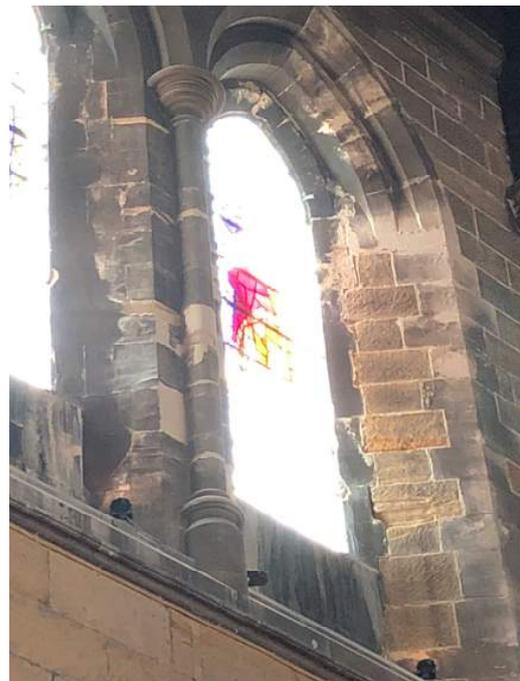
- 12.4 There is some disturbance to stonework and jointing etc. where walls are below external ground levels; for example on the north side of the Church, northwest Porch and low levels in the Calvary Chapel.
- 12.5 There is also disturbance to internal stonework where this has been affected by salts and has caused decay; for example the north window of the Lady Chapel and stone window framework in the St. Mary Magdalene Chapel. I advise repair.

Where the damage is caused to the Lady Chapel window, this may be due in part to the external sheeted window guards limiting natural evaporation.

- 12.6 Deterioration of stonework and pointing to the window embrasures of the clerestory windows and west end windows is evident, which is due to salts build up and migration through the structure which has been mentioned earlier in this report. I advise repair as this is a weakness in the structure which will lead to damp and water penetration.

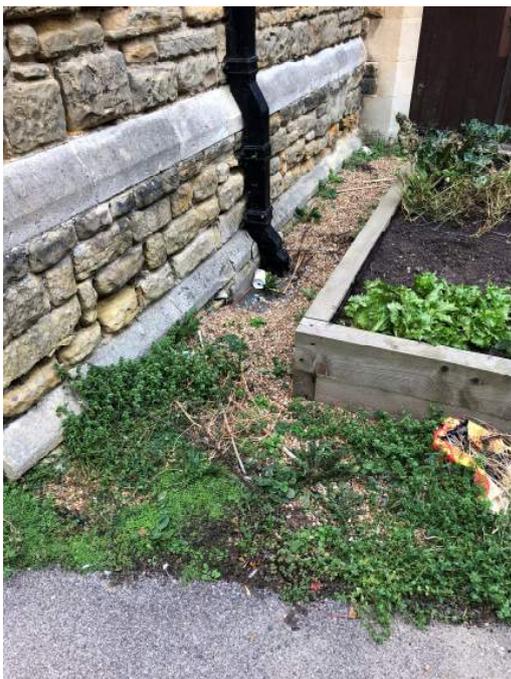
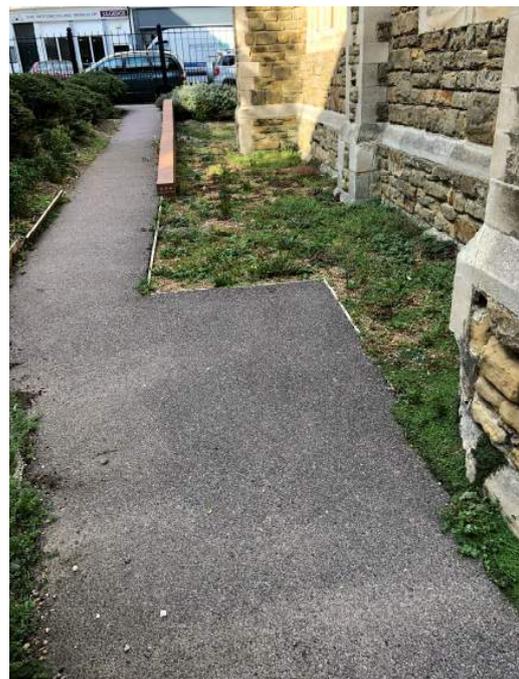
- 21.5 The upper garden to the Rectory and to the west of the Church is to varying levels with sloping paving towards the Church. This will be a contributory factor to the build up of rainwater against this west wall and possible water penetration at Crypt level.

Mention was made earlier in the report of the shingle that has been used over plastic weed control sheeting and this may be inhibiting evaporation of moisture and may lead to ponding of water against the external wall.

A raised garden bed at the west end of the South Aisle is also with plastic liner and similar comments will apply.
